Phase II: EVALUATION OF COOL PAVEMENT SURFACE TREATMENTS USING FRICTION, TEXTURE AND ADHESION PROPERTIES

**PREPARED FOR:
City of San Antonio**

**REPORT DATE
24 January 2025**

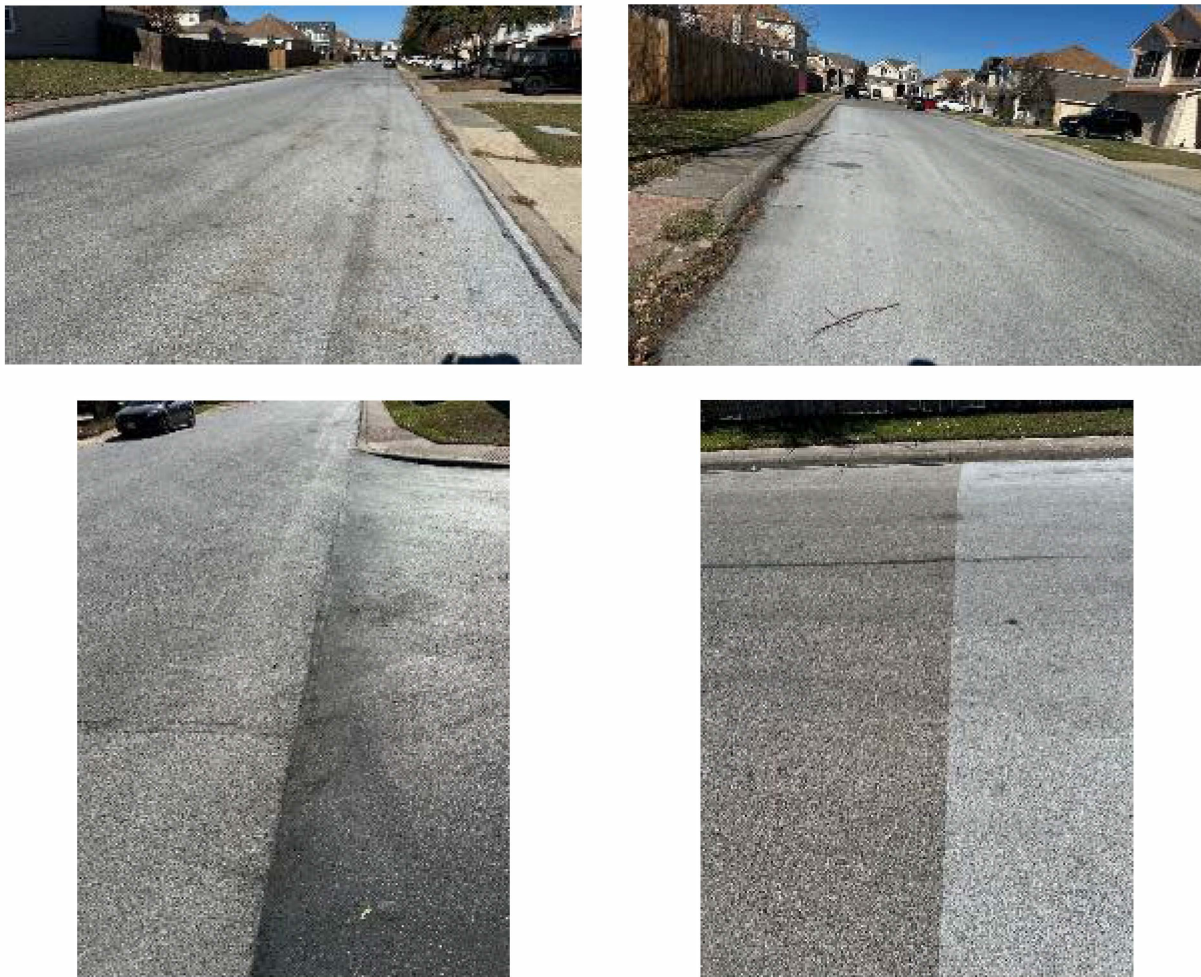
Figure 20. Site photos from Mountain Star.

The SealMaster treatment showed no apparent sign of surface cracking. There was also no sign of delamination or degradation of the treatment particularly on wheelpath. At both ends of the treatment section along the interface with control section, one can notice the color separation line which suggests a fully intact treatment. However, the coloration of the treatment appears to become darkened, particularly in the wheelpath areas as compared to the parking lanes along both directions. Surface discoloration occurred due to tire tracking and oil spills at various locations. Tire tracking is mostly visible on wheelpath and at the turning paths with the intersection of crossing streets. Oil spills appear mostly at the parking lanes. The intensity of the tracking or oil spills is not severe to affect treatment integrity and adhesion with existing pavement surface. Overall, the SealMaster treatment from the preservation perspective seems to function fairly well (Figure 20).

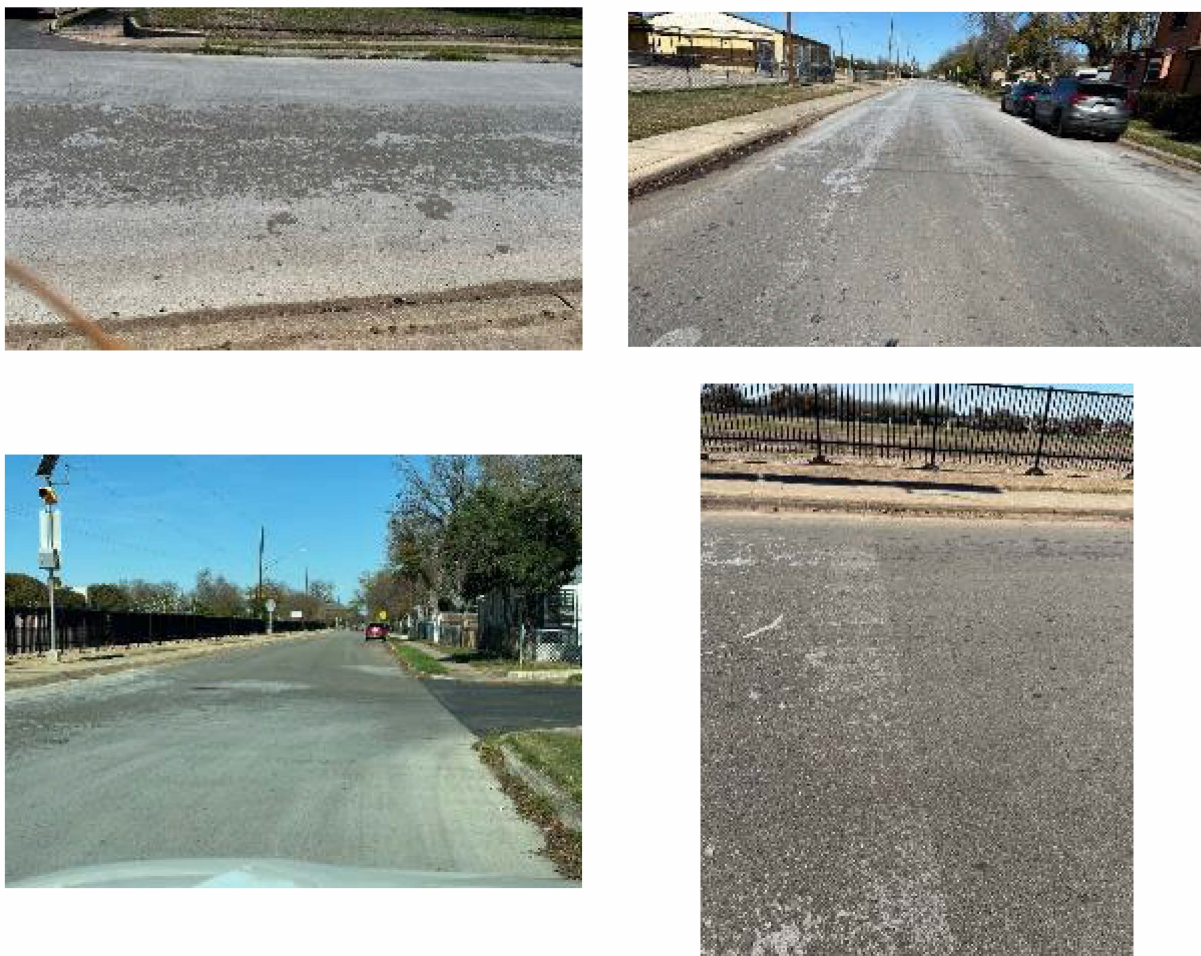
Figure 21. Site photos from SW 21st St.

There was no apparent sign of excessive surface cracking with the exception of outer wheelpath (near sidewalk) in the opposite direction of the school. However, it was very minimal at time of inspection. It is noticeable from previous visits after rainfall that runoff accumulates along the edges with the side curb. The runoff, however, appears to have no effect on treatment delamination as they occurred primarily on wheelpath.

The discoloration of the treatment is affected by oil spills in few spots at the parking lane. However, they are very limited and have no effect in the treatment adhesion with existing surface. It is also noticeable that the significant difference in light coloration of the applied treatment in the parking lane and traffic lane is attributed to the tire rubber imprint. Overall, the treatment appears to be in poor condition due to high volume school traffic (Figure 21).

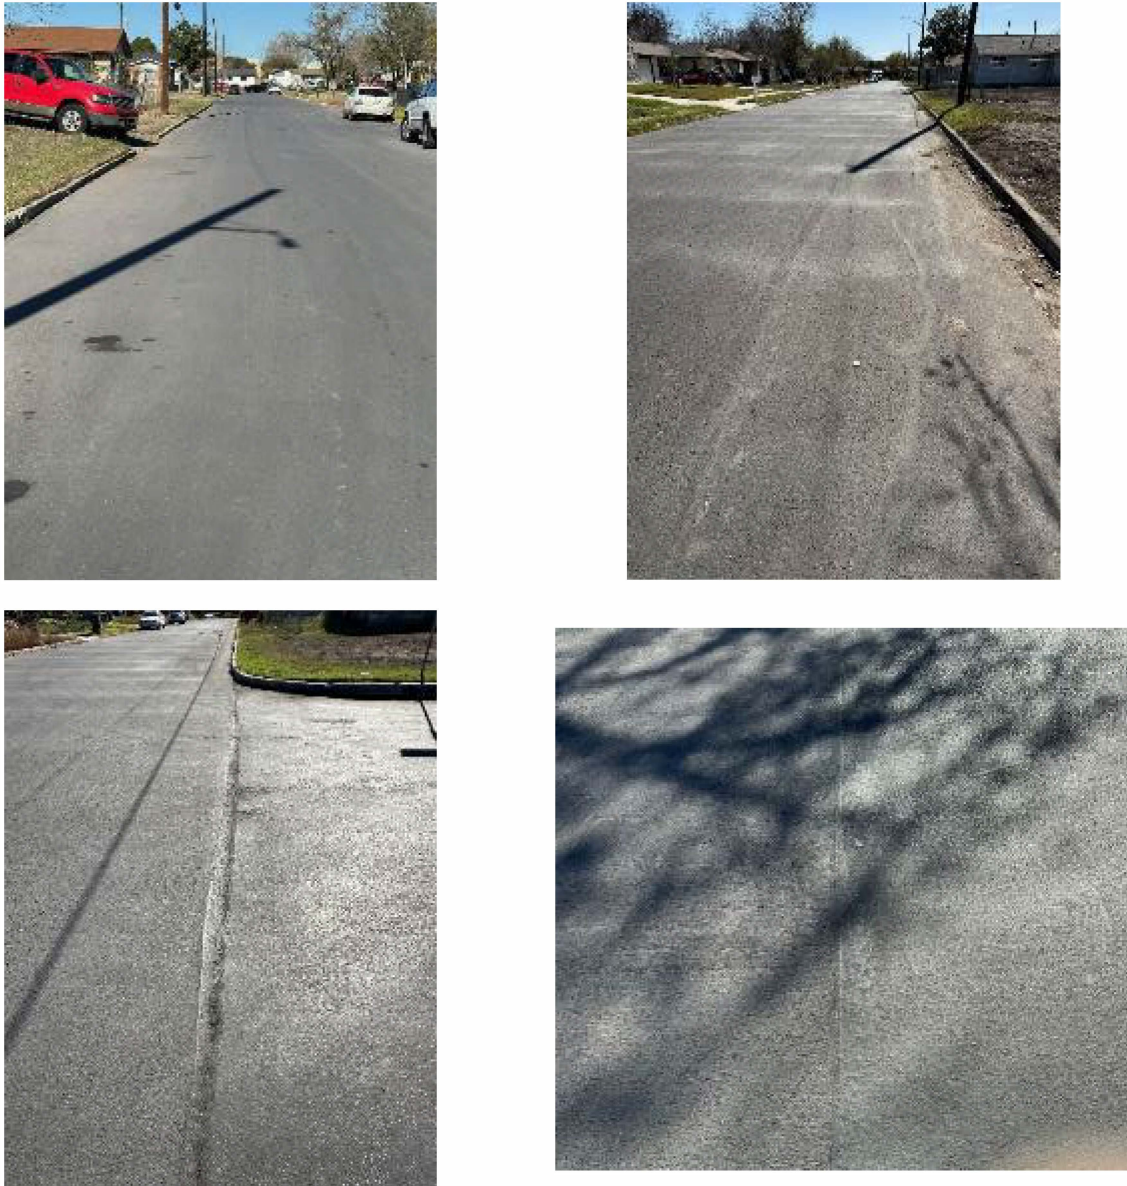
Figure 22. Site photos from Carol Crest St.

The GAF surface treatment appeared to be free from cracking and delamination from existing pavement. The treatment surface color is not clearly distinguished from a freshly applied asphalt pavement toward site ends and intersection with Belinda Lee St.

In terms of discoloration, there are no visible oil spills or tire tracking which may be attributed to the near dark color of the treatment. From the pavement preservation perspective, the treatment seems to function fairly well (Figure 22).

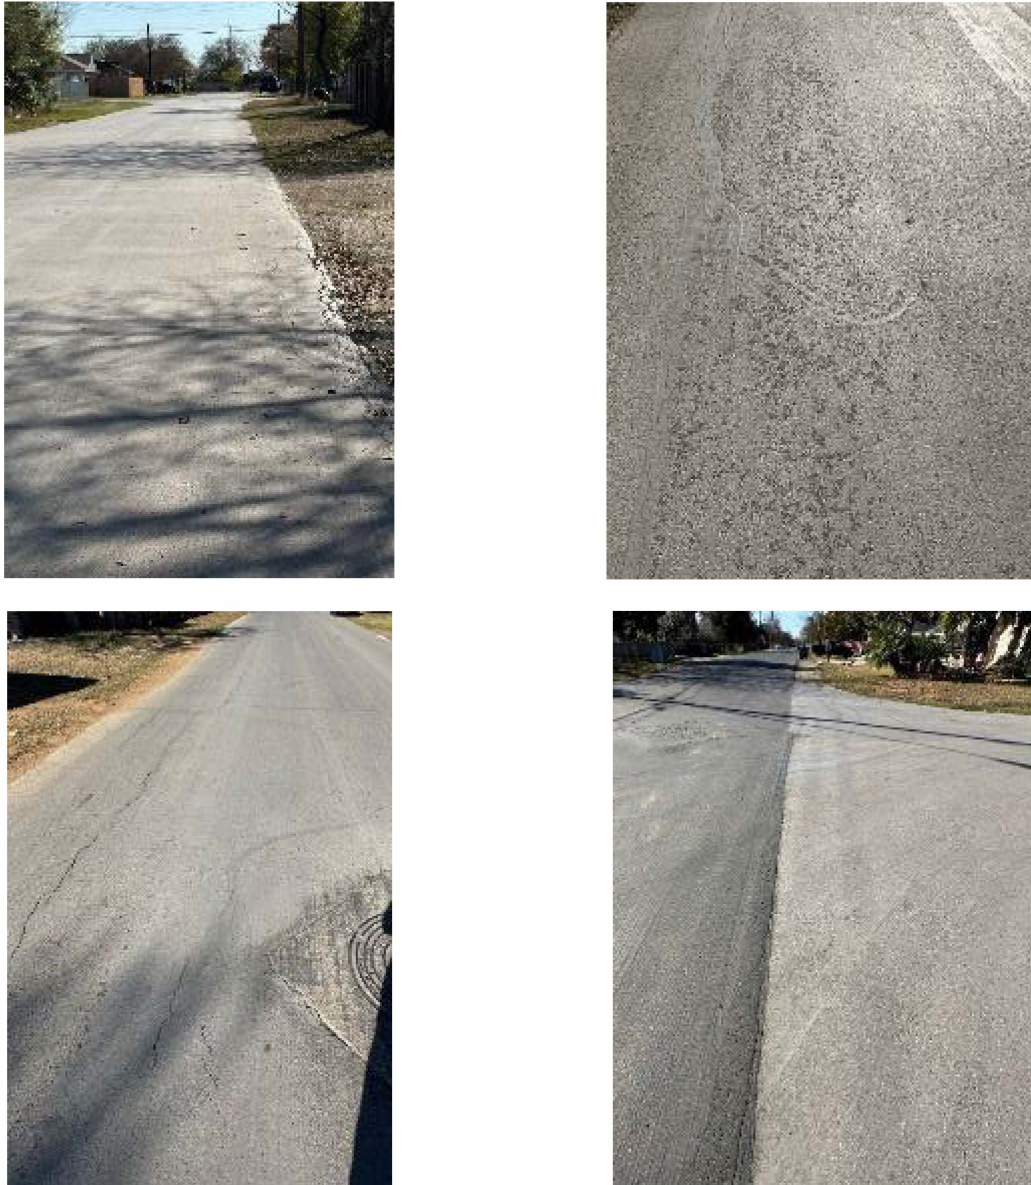
Figure 23. Site photos from Lucinda St.

The GuardTop treatment for the most part of the site appears to be intact with few exceptions on wheelpath in the northbound direction to Ashley rd. This is the only site with no curb and sidewalk which attribute to the longitudinal cracking along the pavement edges in both directions. There is also noticeable longitudinal cracking on wheelpath in both directions with few that were previously sealed prior to the treatment. The width of non sealed cracks warrants the need for crack sealing treatment. In terms of the treatment discoloration, there is no sign of oil spills or tire tracking. Overall, the treatment appeared to be in acceptable condition considering the low traffic and lack of curbs that protect against pavement edges failure (Figure 23).

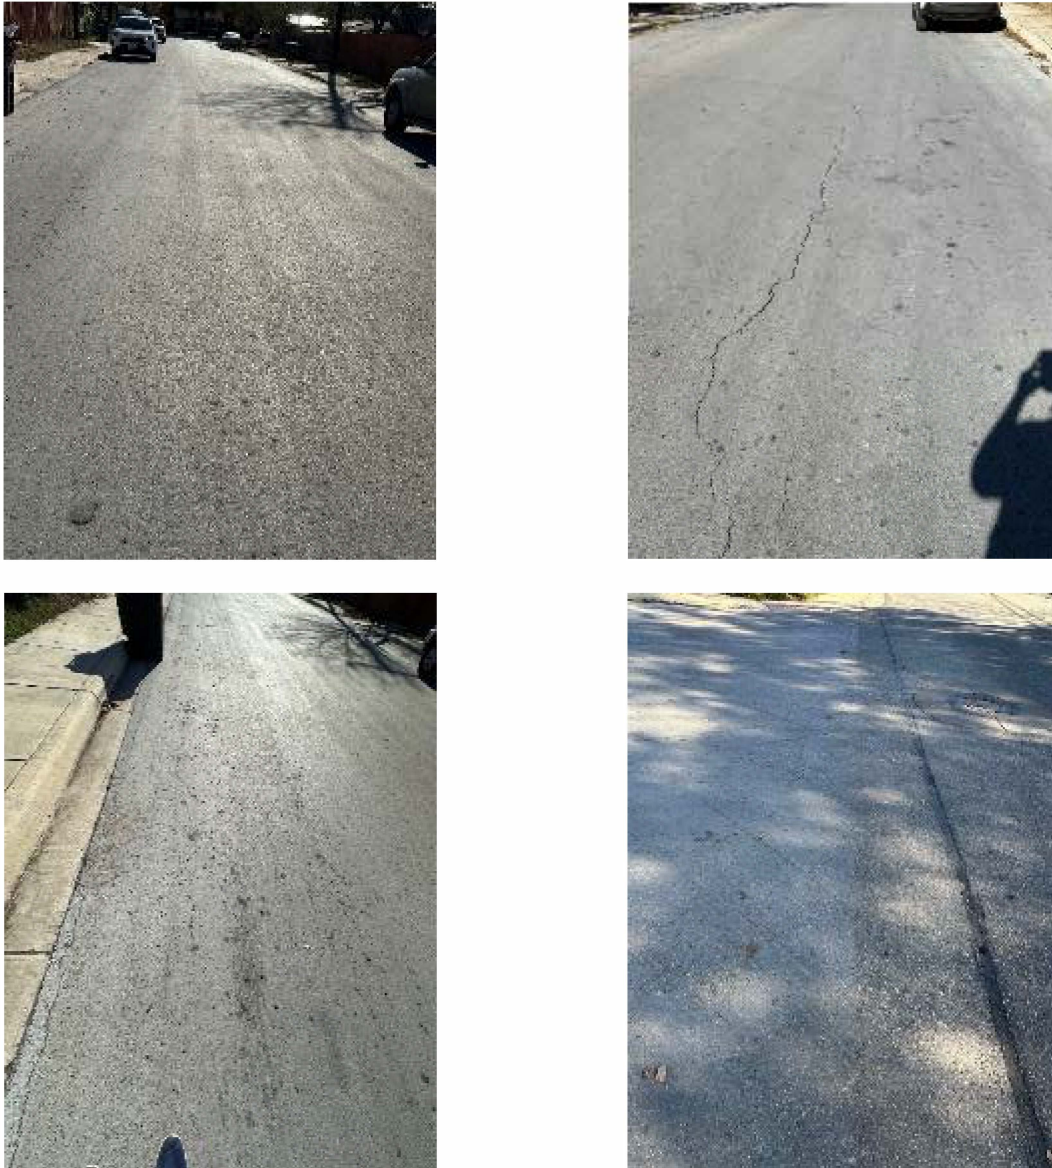
Figure 24. Site photos from Piper Dr.

The GuardTop treatment showed no delamination. With the exception of single longitudinal crack, the surface seems to be fully intact and well covering of existing pavement. Tire tracking is the most visible discoloration noticed in most areas of the treatment attributed to contrast of tire rubber and light treatment color. There is no significant difference in the treatment color at the interface with conventional pavement surface at Freeman Dr. Overall, the treatment appeared to be in fairly well conditions due to its adhesion and coverage to existing surface (Figure 24).
